ET Door Drive Actuator Anomalies & Repair Plan

**Jeff Goodmark
Boeing Mechanical Systems SSM**

**OPO Technical Tagup
06/18/08**

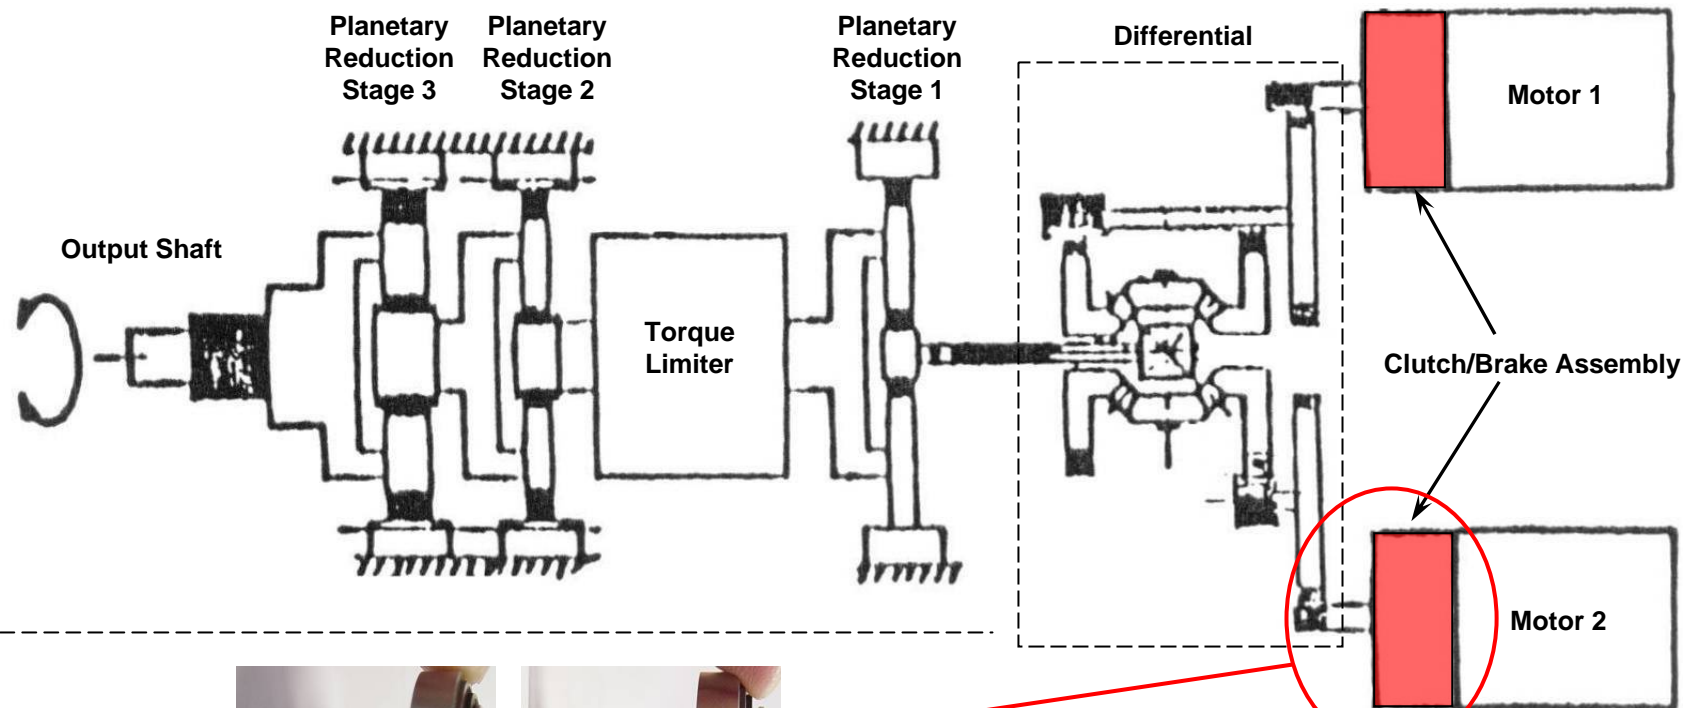
ET Door Drive Actuator

Brake mode:
Disk spring-loaded
against stator, locks
input to differential.
Motor output is
disengaged.

Clutch mode:
Disk magnetically
pulled away from
brake stator,
allowing rotation.
Motor output is
engaged.
